ADDENDUM No. 4

Project Name: **TOWN OF HILTON HEAD ISLAND
REQUEST FOR PROPOSALS
RFP 2016-0015 FIRE STATION TWO**

Asbestos Containing Materials Report

Re: Asbestos Building Assessment Report
Fire Station No. 2
65 Lighthouse Road
Hilton Head Island, Beaufort County, South Carolina

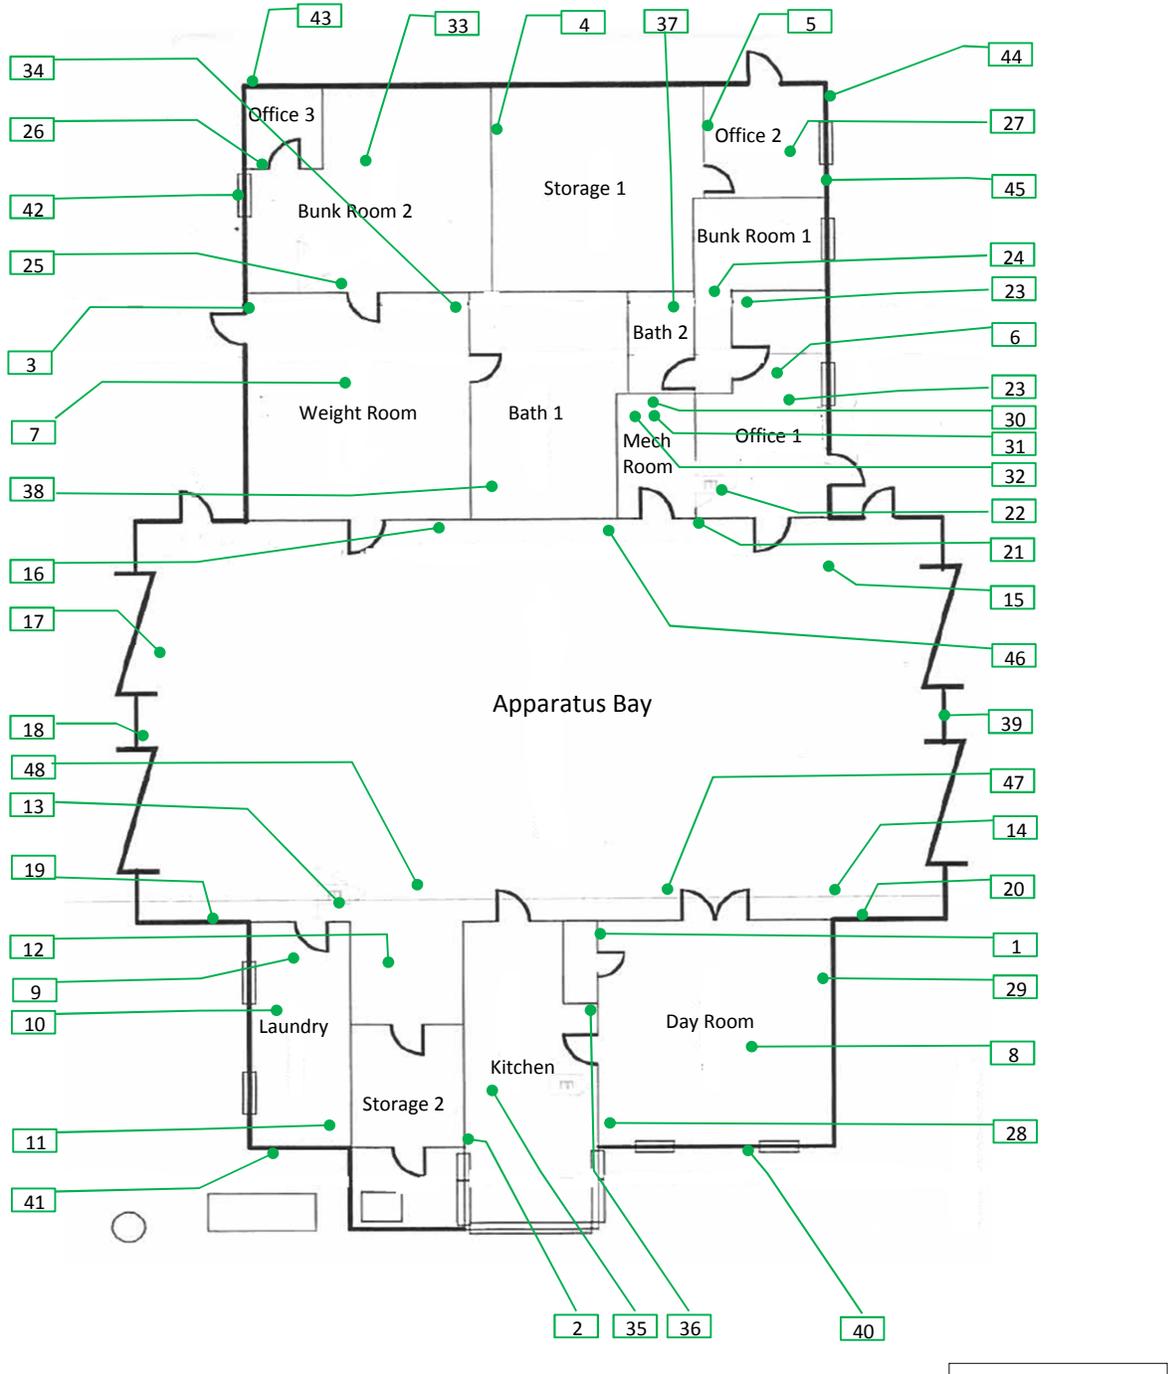
Figure 1. Demolition Area, Sample Locations, and Photograph Locations

Our fieldwork identified a total of seventeen (17) HAs of material classified as *miscellaneous* and *surfacing*. The materials included consisted of two layers of vinyl floor tile (VFT) and associated mastic (≈230 ft²), drywall walls and associated joint compound (≈2,775 ft²), drywall ceiling and associated joint compound (≈2,875 ft²), ceiling tile 1 (≈2,000 ft²), ceiling tile 2 (≈175 ft²), wall covering and associated mastic (≈2,675 ft²), carpet mastic (≈1,100 ft²), duct mastic (≈100 ft²), roof insulation (≈2,300 ft²), roof sealant (≈100 ft²), stucco (≈3,000 ft²), shingles (≈2,775 ft²), and roof paper (≈2,775 ft²). Representative bulk samples of each suspect ACM were collected in general accordance with the protocol required by EPA 40 CFR, Part 61, (NESHAP). The samples were submitted to an NVLAP accredited laboratory (#200664-0) for analysis using PLM by method EPA/600/M4-82/020 and TEM Chatfield where applicable. A sketch detailing the locations where samples were collected

is attached as **Figure 1**. Select photographs taken during our inspection are included as **Attachment A**.

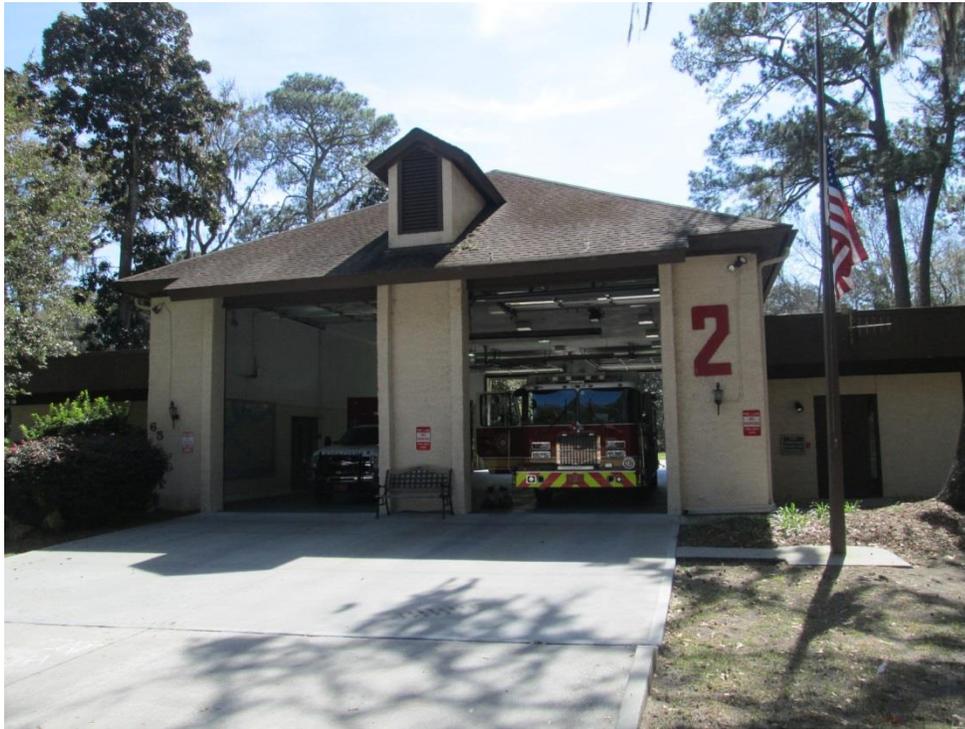
Photo 1 – Fire Station No. 2, 65 Lighthouse Road, Hilton Head Island, South Carolina.

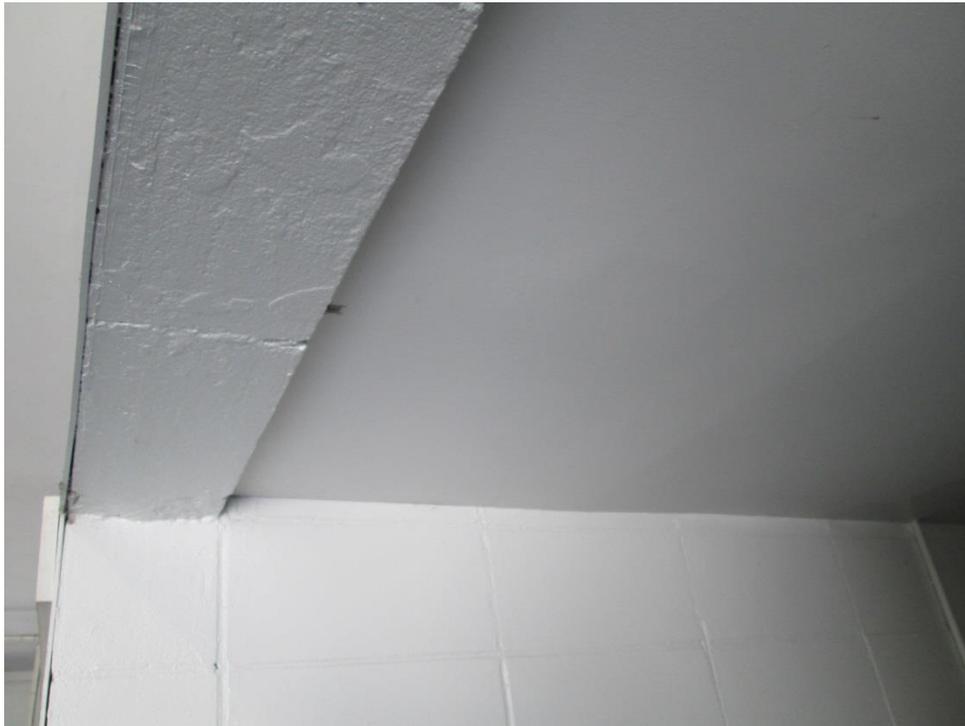
Photo 2 – View of the drywall ceilings.

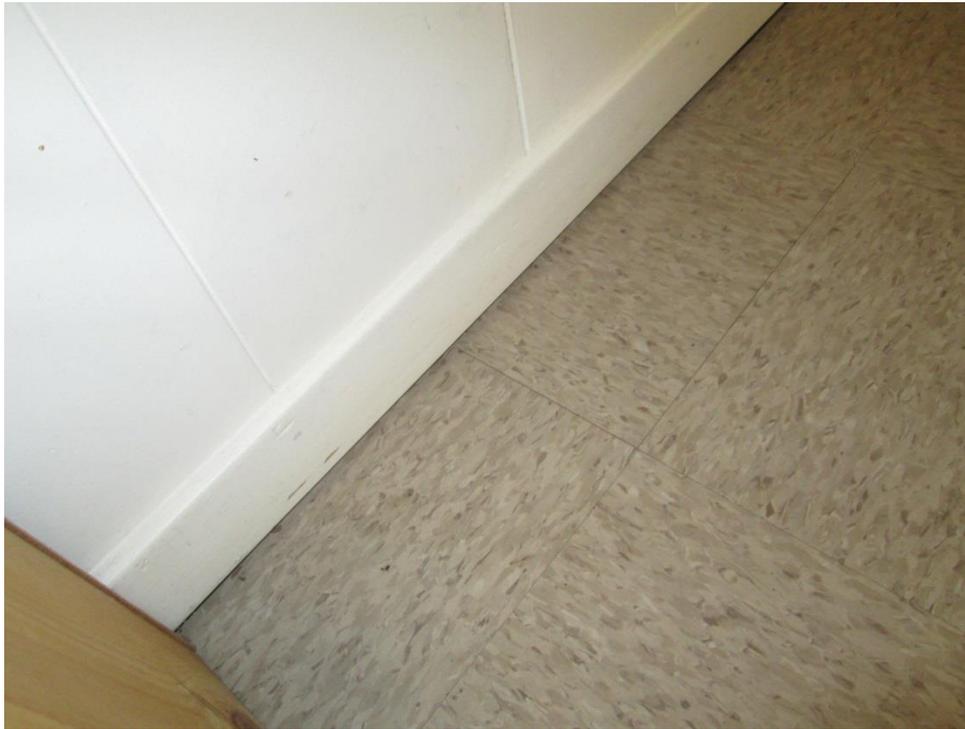
Photo 3 – View of the VFT flooring.

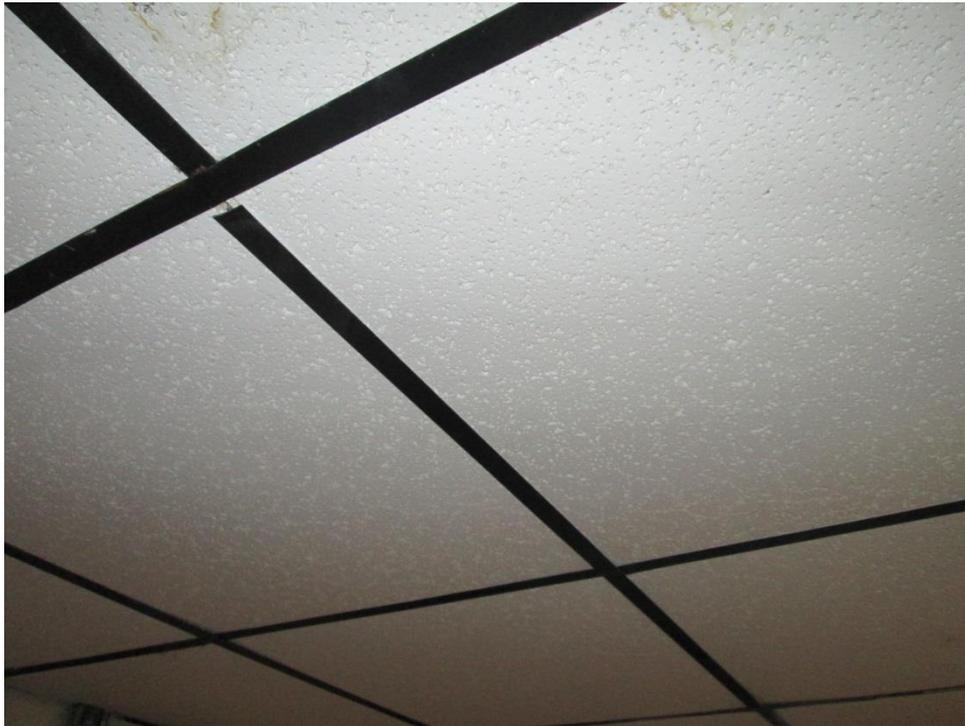
Photo 4 – View of ceiling tile 1.

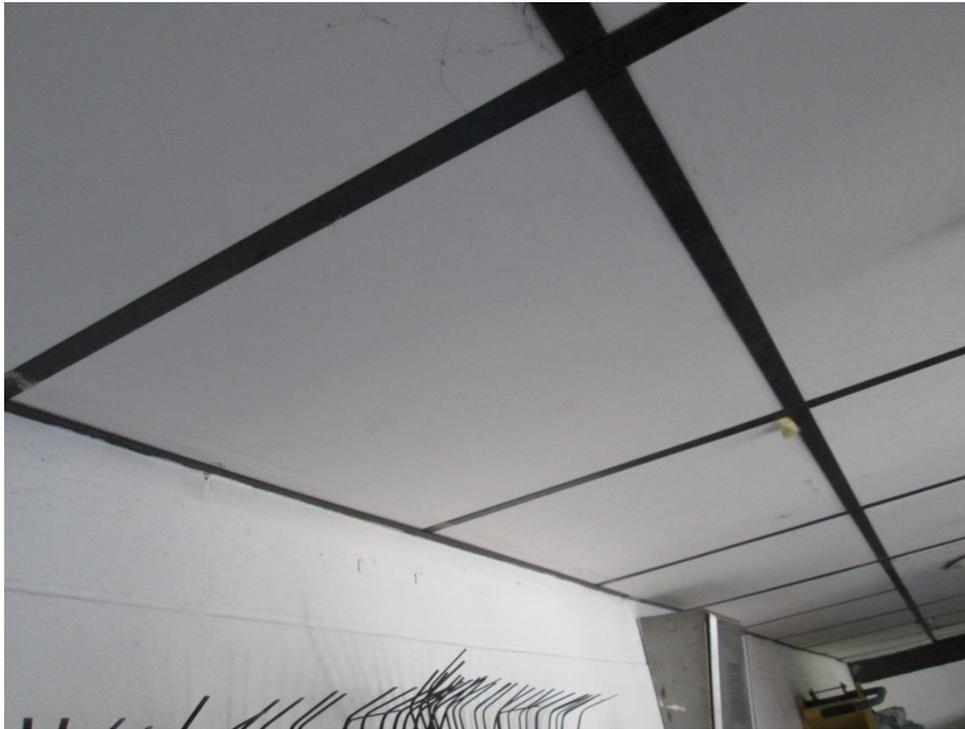
Photo 5 – View of ceiling tile 2.

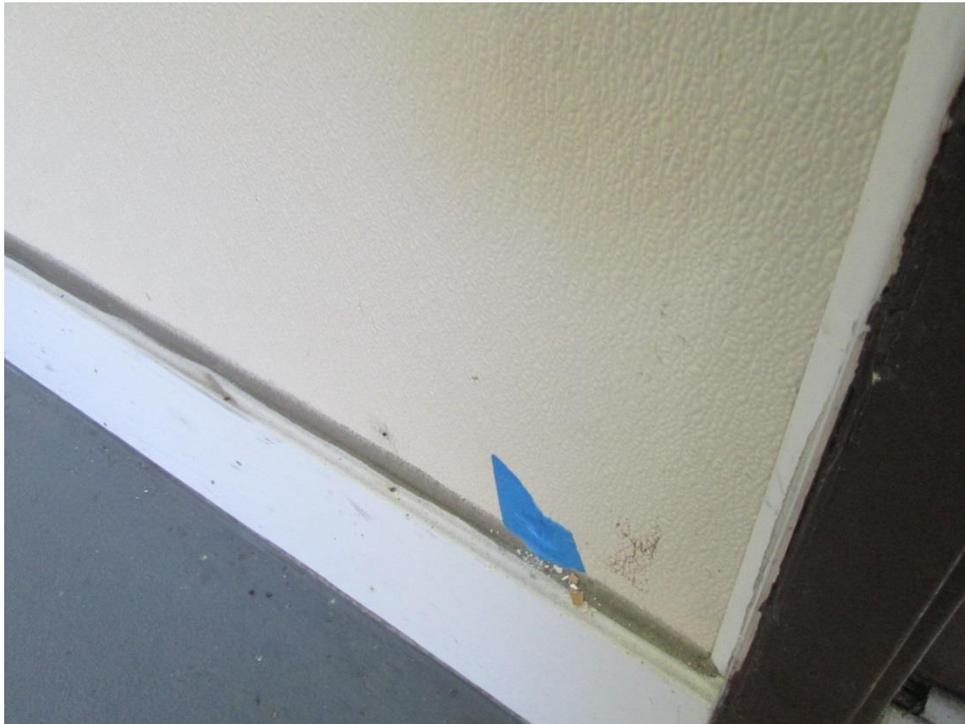
Photo 6 – View of the wall covering in the Apparatus Bay.

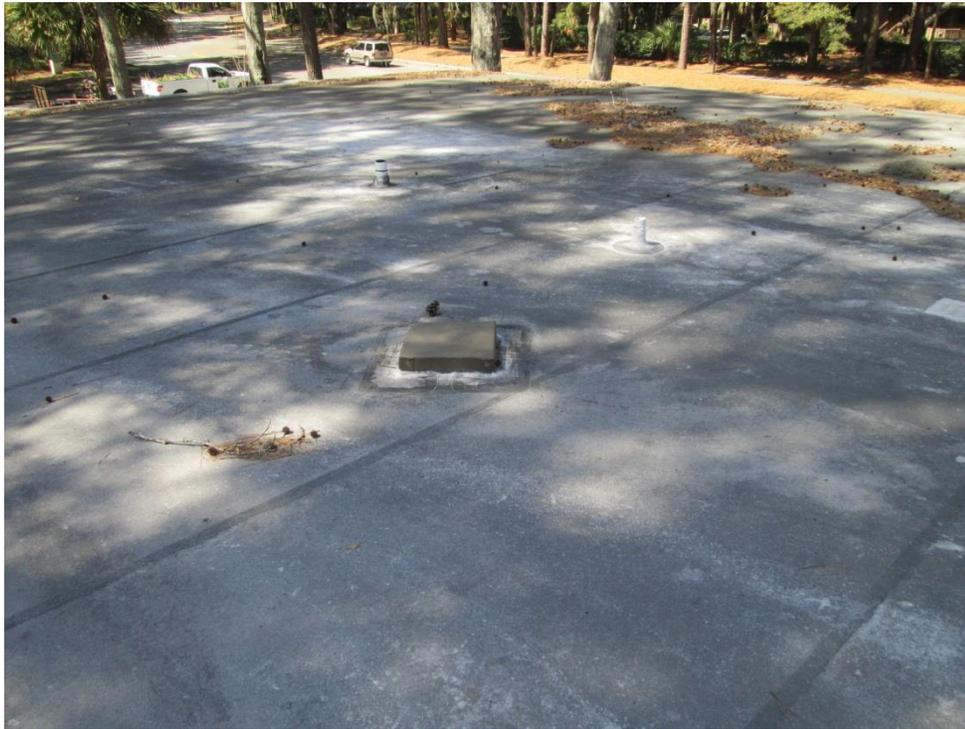
Photo 7 – View of the heat sealed membrane flat roof.

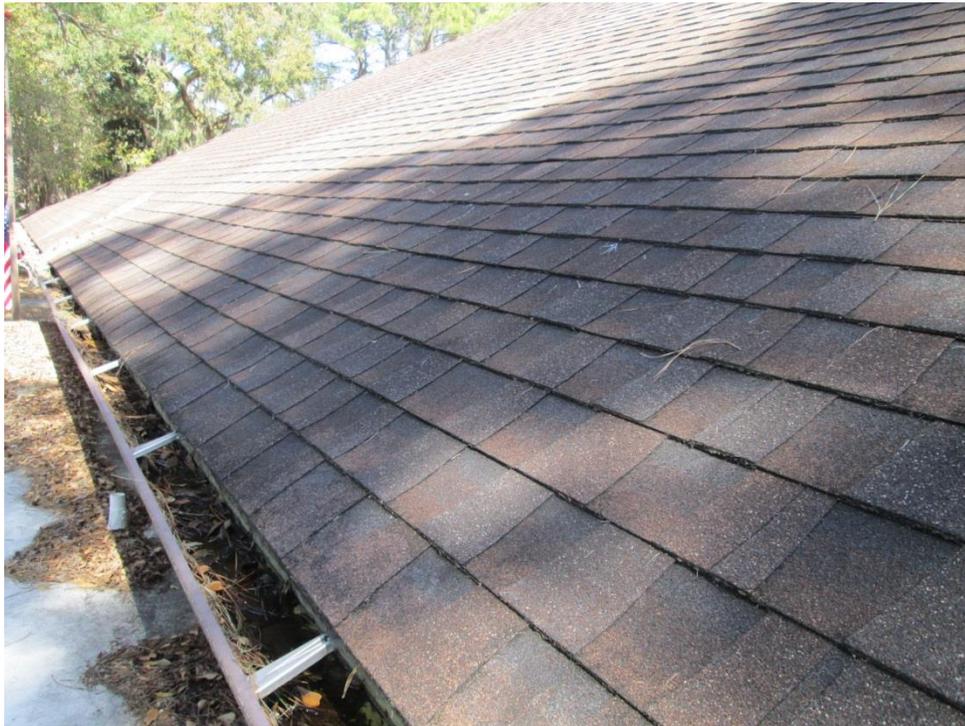
Photo 8 – View of the asphalt shingle roof.
